**Analisi non invasive per la caratterizzazione degli affreschi nella Reception Room
del Senato degli Stati Uniti d'America**

**Non-invasive analysis for the characterization of Fresco in the Senate Reception
Room of the United States Capitol Building**

Michele Maccione

A.A. 2018 / 2019

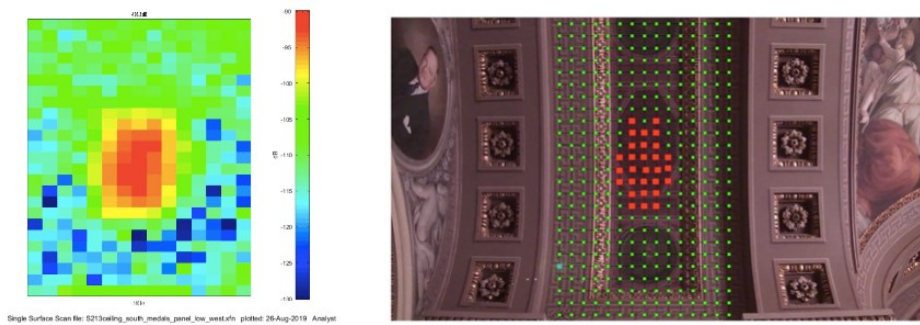
Two major anomalies were found in this area, one in the lower west portion (Section 1) and one in the middle of the east portion of the archway (Section 4). Sections 2, 3, 5 show little or no evidence of degradation. [13.]

(Figure 6-3) Section 1 shows a large central anomaly positioned near the edge of the bordering plaster molding. [13.]

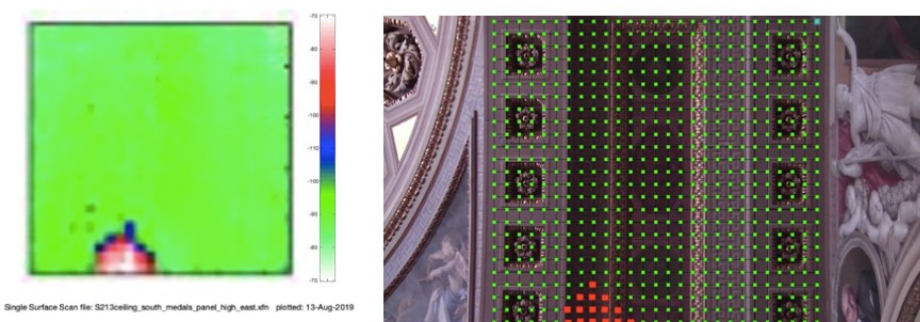
(Figure 6-4) Section 4 shows an anomaly in the bottom center of the panel, under and to the left of the central medal. [13.]

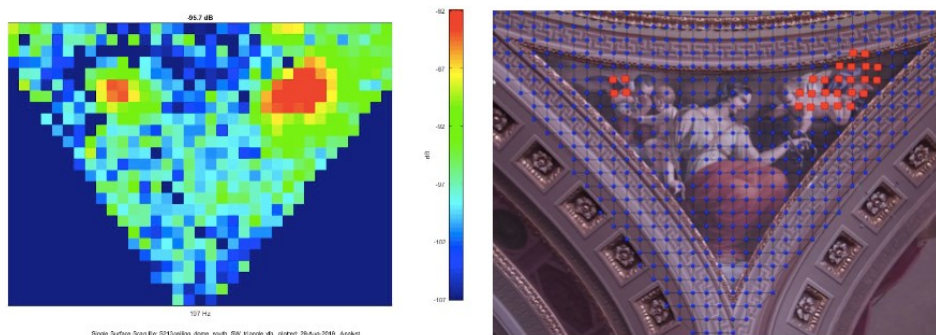
Two major anomalies were found in this area. One is considerably smaller in the upper right area of the south west portrait (Section 6). The other is considerably largest in the entire central portrait at the peak of the dome (Section 10-11). Sections 7, 8, 9, 12 show little or no evidence of degradation.

(Figure 6-5) Section 6 shows two anomalies, one major in the upper right corner, and one minor in the upper left corner. [13.]

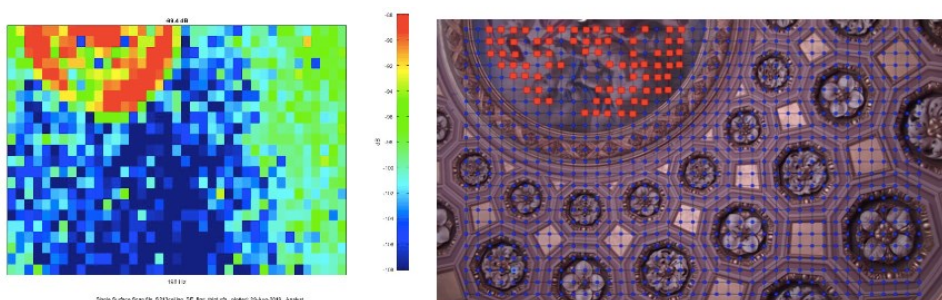
(Figure 6-6) Section 10 shows part of the large anomaly in the central panel. [13.]

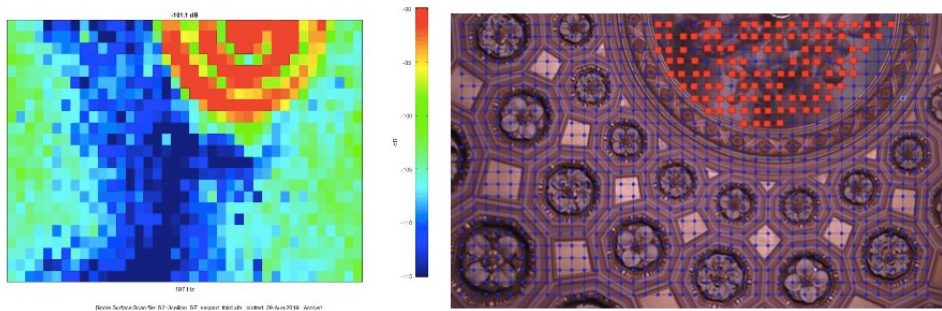
(Figure 6-7) Section 11 shows part of the large anomaly in the central panel. [13.]

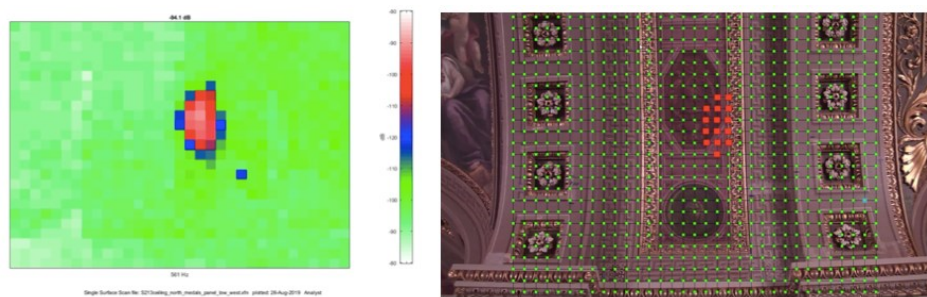
Two major anomalies were found in this area, one in the center of lower west portion (Section 13) and one in the center of lower east Portion (Section 17). Sections 14, 15, 16 show little or no evidence of degradation. [13.]

(Figure6-8) Section 13 shows a large anomaly in the center of the panel. [13.]

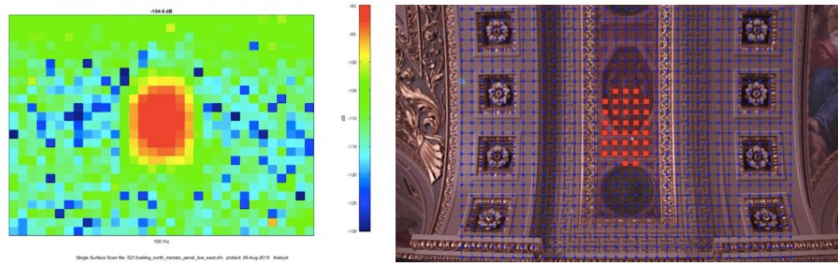
(Figure 6-9) Section 17 shows a large central anomaly that spans almost the entire width of the central panel. [13.]

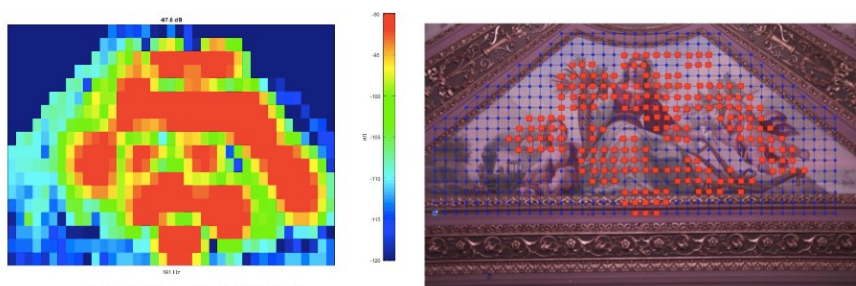
In this area all four sections showed major delaminations. There were four minor faults detected. One in the east panel (Section 21), one in the north panel (Section 20) and two in the west panel (Section 19). There was also one ambiguous area detected in the lower left side of the panel (Section 21). [13.]

(Figure 6-10) Section 18 shows a large anomaly covering almost the entire surface. [13.]

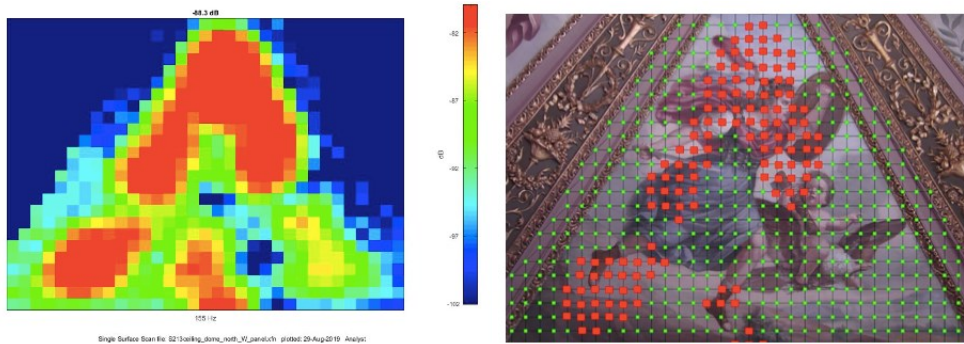
(Figure 6-11) Section 19 shows a number of large and small anomalies that cover a large section of the surface. [13.]

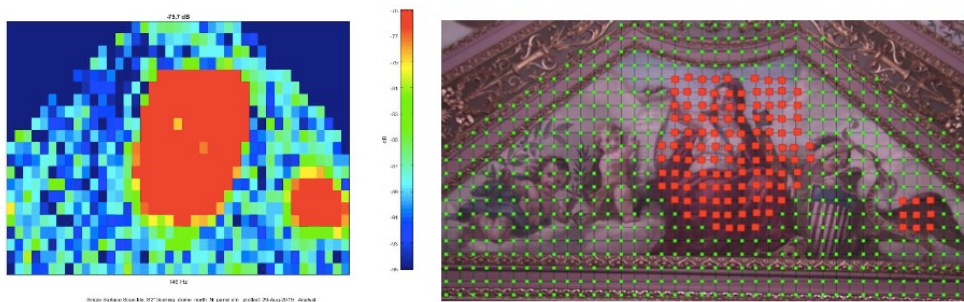
(Figure 6-12) Section 20 shows a large central anomaly and an additional smaller anomaly near the bottom right corner. [13.]

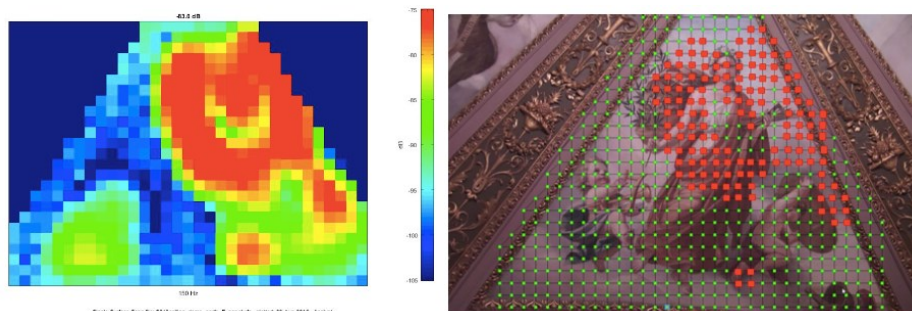
(Figure 6-13) Section 21 shows a large anomaly that covers a large section of the right and center surface. [13.]

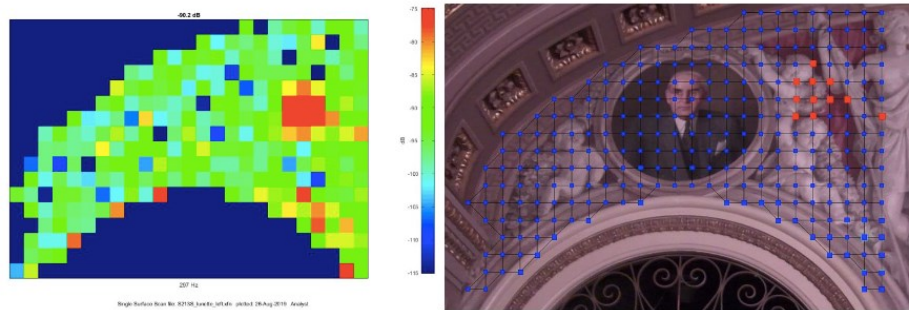
The wall shows a number of small anomalies in the center of lunette (Section 1-2) and two large anomalies around the border of the portrait (Section 4). Section 3 shows little or no evidence of degradation.

(Figure 6-15) Section 1 shows a small anomaly near the top right side. [13.]

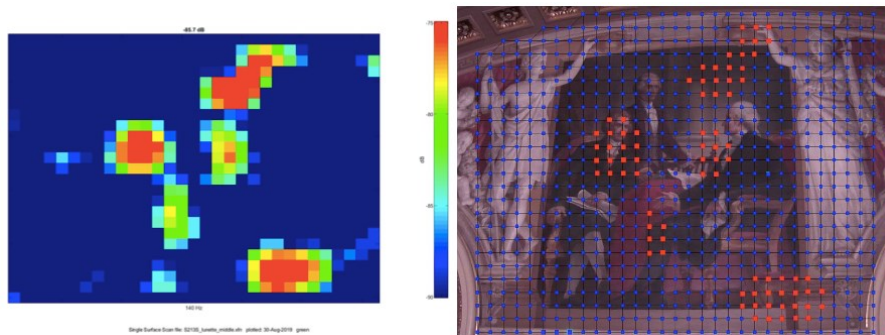
(Figure 6-16) Section 2 shows five small anomalies over the central region of the portrait. [13.]

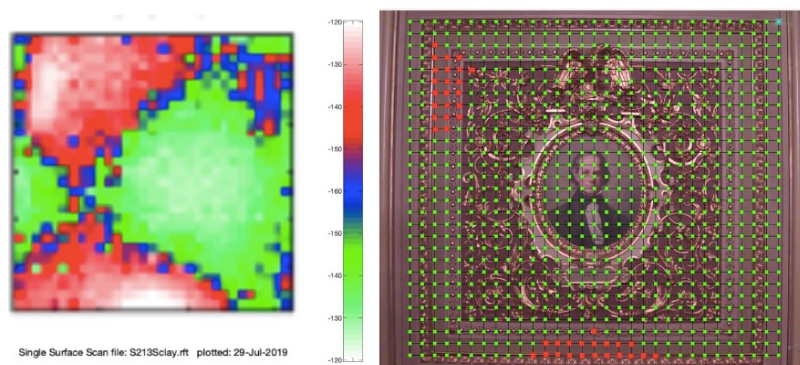
(Figure 6-17) Section 4 shows an anomaly in the top left corner and the centrally along the bottom. [13.]

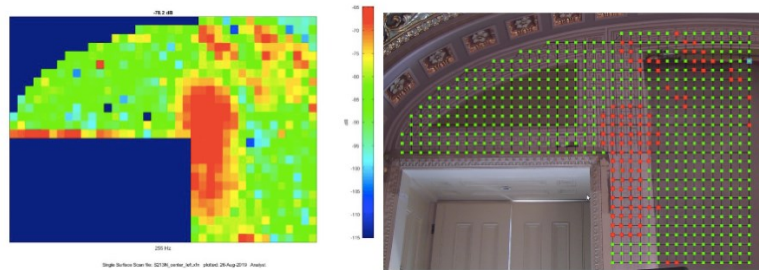
Anomalies on the north wall include three large areas along the windows (Section 3) and few small areas in the top of the lunette (Section 1-2). [13.]

(Figure 6-19) Section 1 shows a large anomaly in the center at the top right corner of the window and two smaller anomalies in the top right corner of the scan. [13.]

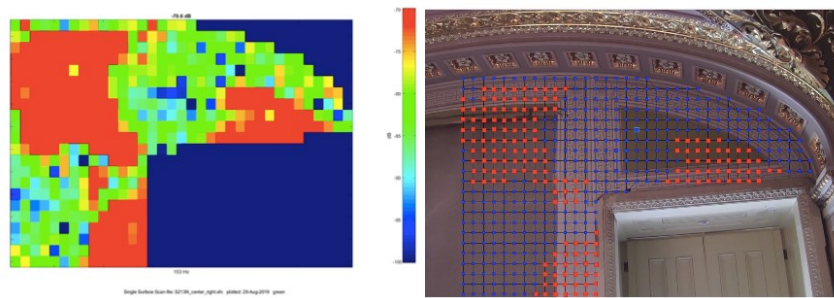
(Figure 6-20) Section 2 shows an anomaly in the top left corner, along the side of the window and above the window. [13.]

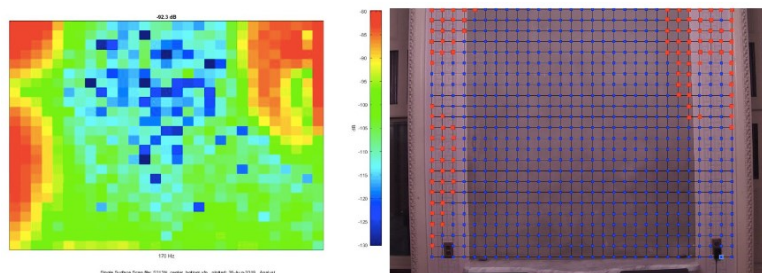
(Figure 6-21) Section 3 shows two large anomalies along the left side and a large anomaly in the top right corner. [13.]

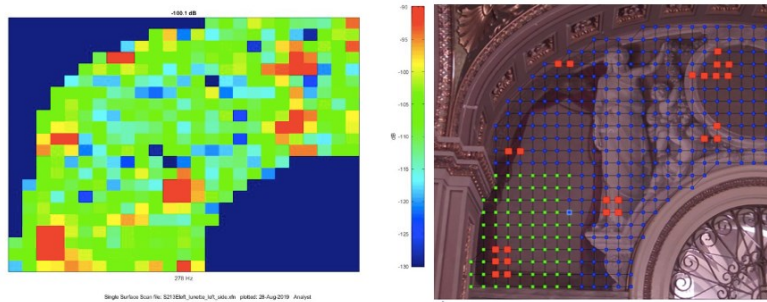
The wall shows a number of small and large anomalies along the upper edges and bottom corners of the lunettes (Section 1-2-3-4). Both medals panels have large single anomalies (Section 5-6-8). The northern door panel shows a large central anomaly while the southern door panel shows four (Section 9-10). The outer plaster surrounding the portrait of Senator Taft shows a large anomaly running along the bottom edge (Section 11). Section 7, 12 shows little or no evidence of degradation.

(Figure 6-23) Section 1 shows several small anomalies across the surface of the fresco. [13.]

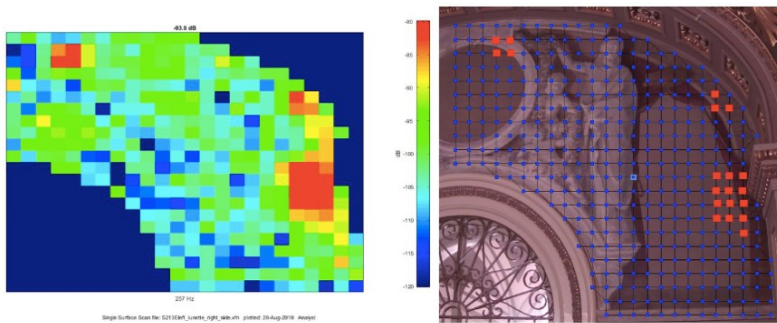
(Figure 6-24) Section 2 shows one large anomaly near the bottom right corner, as well as two smaller anomalies along the top of the lunette. [13.]

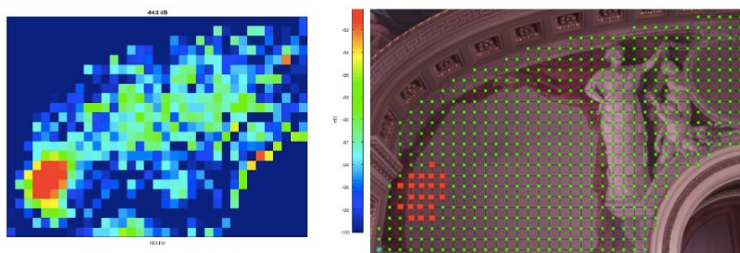
(Figure 6-25) Section 3 shows one large anomaly near the bottom left corner of the lunette. [13.]

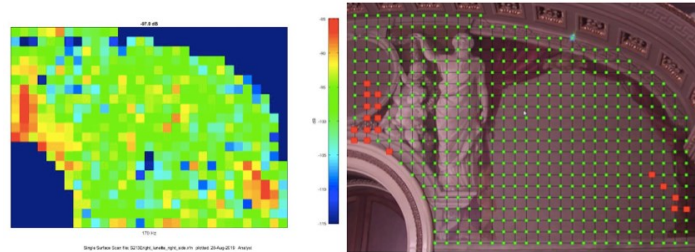
(Figure 6-26) Section 4 shows one large anomaly near the bottom left corner of the lunette and one small anomaly near the bottom right corner. [13.]

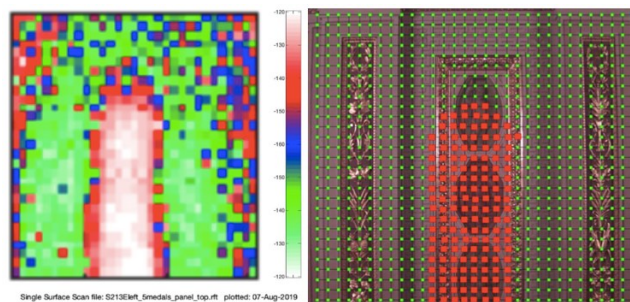
(Figure 6-27) Section 5 shows one large anomaly that covers the entire bottom of the central panel. [13.]

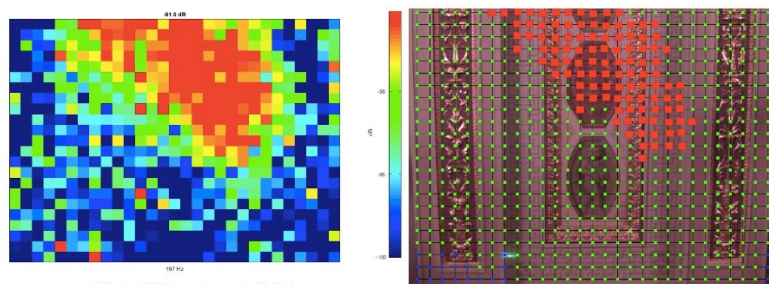
(Figure 6-28) Section 6 shows one large anomaly that covers the entire top of the central panel and extends half way down the fresco. [13.]

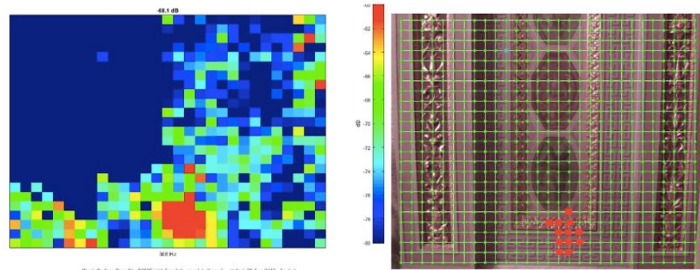
(Figure 6-29) Section 8 shows one large anomaly at the bottom of the outer panel and extends through the inner molding and into the very bottom of the central fresco. [13.]

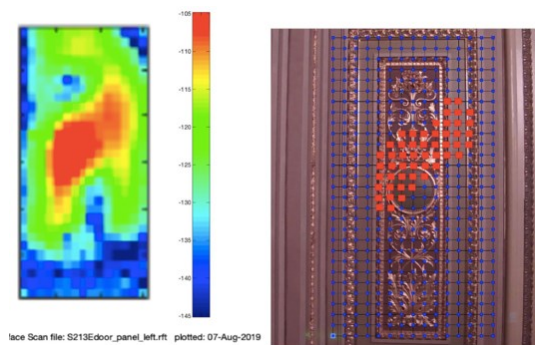
(Figure 6-30) Section 9 shows one large anomaly at the upper center of the panel. [13.]

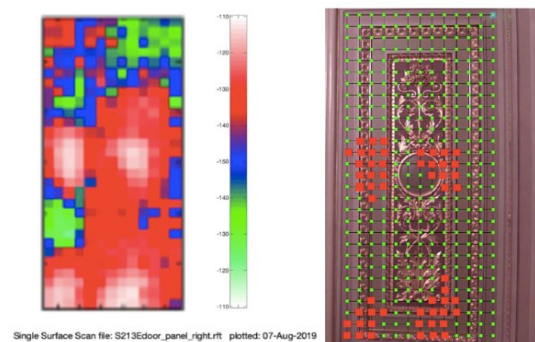
(Figure 6-31) Section 10 shows two large anomalies in the bottom left, bottom center, and middle left of the outer fresco as well as the middle center of the inner decorative molding panel. [13.]

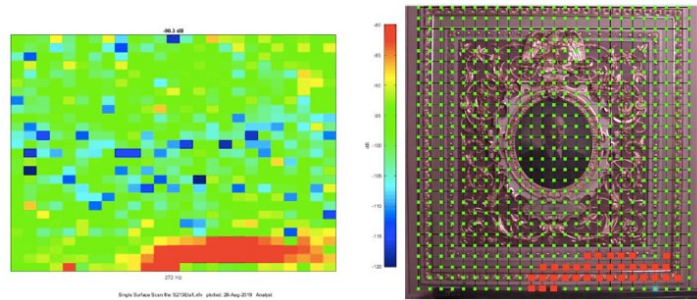
(Figure 6-32) Section 11 shows a large anomalies along the bottom of the external fresco. [13.]

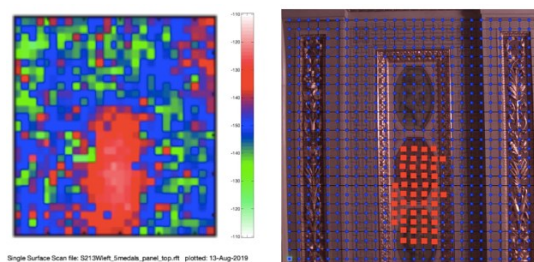
The wall shows multiple large anomalies in the upper medals panels (Section 1-5) and smaller anomalies in the door panels (Section 11-12). The northern lunette shows three small anomalies around the edge (Section 7-8). The southern lunette contains two large anomalies (Section 3). Section 2, 4, 6, 9, 10 shows little or no evidence of degradation. [13.]

(Figure 6-34) Section 1 shows one large anomaly in the center of the interior medals panel. [13.]

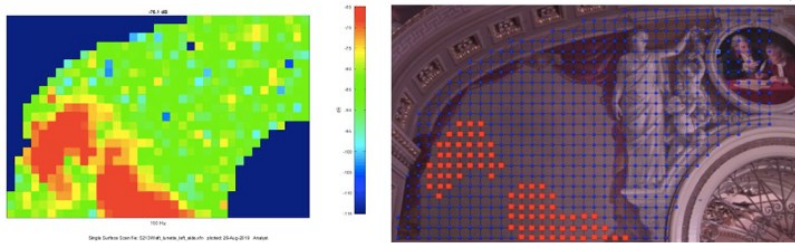
(Figure 6-35) Section 3 shows one major anomaly near the bottom left corner.

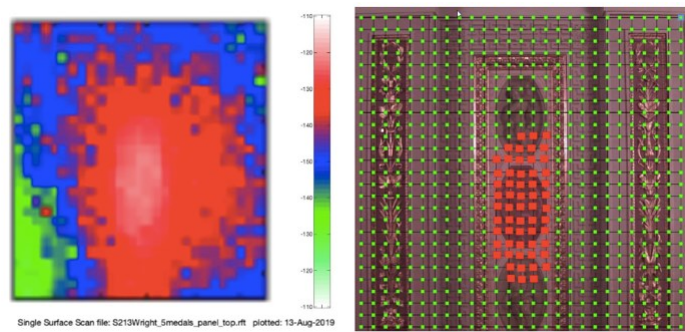
(Figure 6-36) Section 5 shows one major anomaly in the center of the fresco.

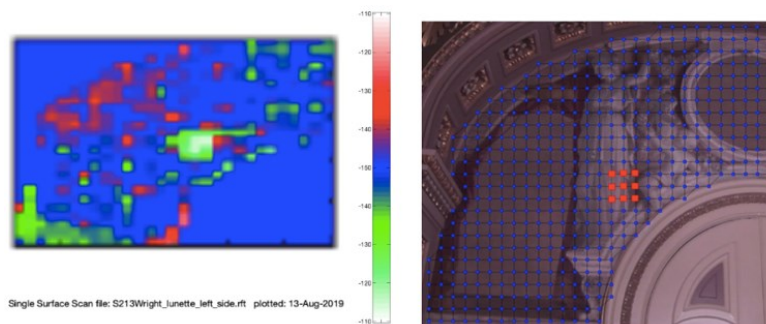
(Figure 6-37) Section 7 shows one minor anomaly in the center of the fresco.[13.]

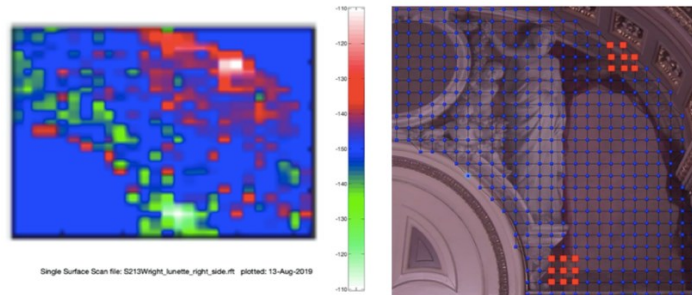
(Figure 6-38) Section 8 shows two minor anomalies, one in the lower left corner and one near the top right edge of the fresco. [13.]

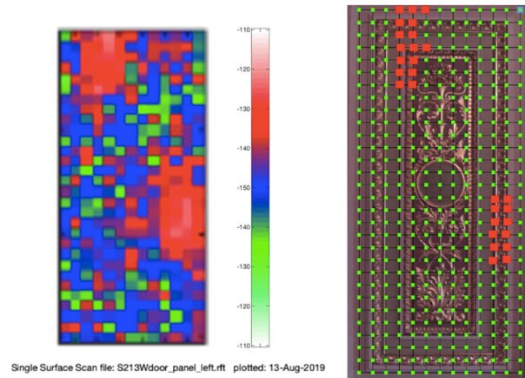
(Figure 6-39) Section 11 shows shows two major anomalies, one on the top left of the panel and the other on the center right side. [13.]

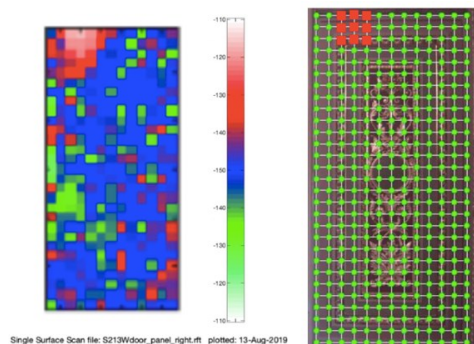
(Figure 6-40) Section 12 shows one minor anomaly at top let corner of this panel.
