**Analisi non invasive per la caratterizzazione degli affreschi nella Reception Room
del Senato degli Stati Uniti d'America**

**Non-invasive analysis for the characterization of Fresco in the Senate Reception
Room of the United States Capitol Building**

Michele Maccione

A.A. 2018 / 2019

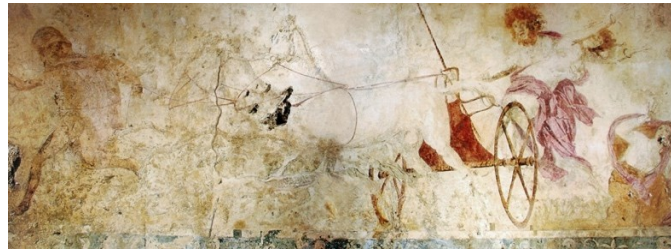
passes, they cause a not perfect contact between the layers. As the time passes, because of the humidity trapped on the cavity caused by the detachment, the delaminated area propagates. The fresco can suffer huge damages, until the real physical detachment of a layer from another one, or from parts of it. Even if there isn't a detachment, the delamination can damage the aesthetics of the fresco itself, so the loss of a work of art. Some example of frescos are reported in the following figures where the detachment of the layers can be seen.

(Figure 3-3) Hades Abducting Persephone in the Small Royal Tomb at Vergina, Macedonia Greece.

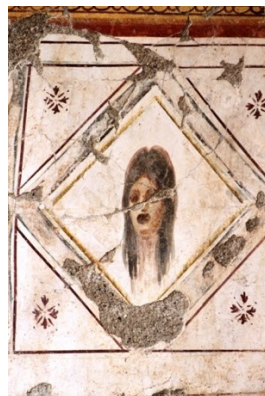
(Figure 3-4) Fresco in the terrace houses in Ephesus at Selcuk, Turkey.

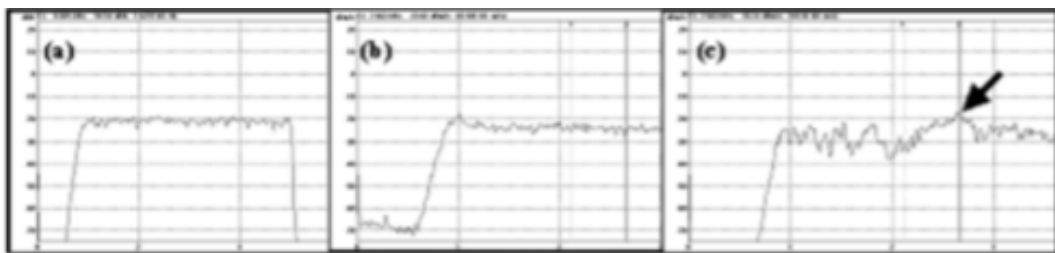
In the figure (5-4) there is an example relative of the measurement executed on a fresco, starting from the signal used for the acoustic solicitation (white rumour) a small defected area is identified thanks to the presence of a resonance peak at 2663 Hz. [9.]

(Figure 5-4) (a) White noise signal input to the loudspeakers (b) spectrum measured on untouched area (c) spectrum measured on detached area.

Notice the resonance peak found (black indicator) [9.]

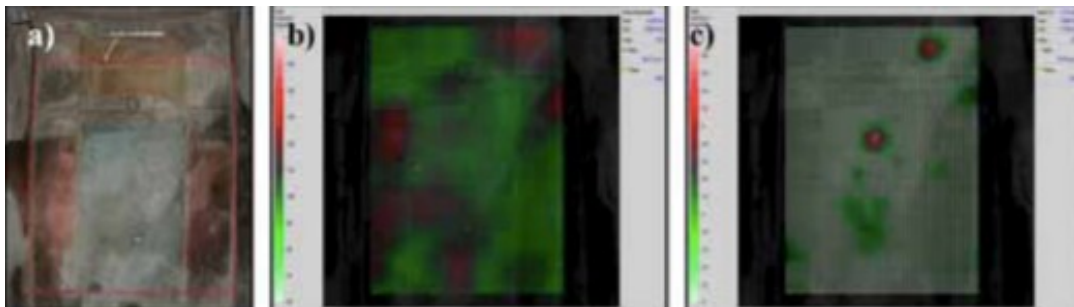
In the figure (5-5) there is a wall analysed with the relative map RMS. The lecture is immediate: the color green is associated to a low level of vibration (the structure is in a good state of conservation); the color red is associated to a high level of vibration (the structure has pathological conditions in progress, as delamination or detachment).

(Figure 5-5) (a) detail of the wall (b) RMS map (c) RMS map 1690-1740 Hz [9.]

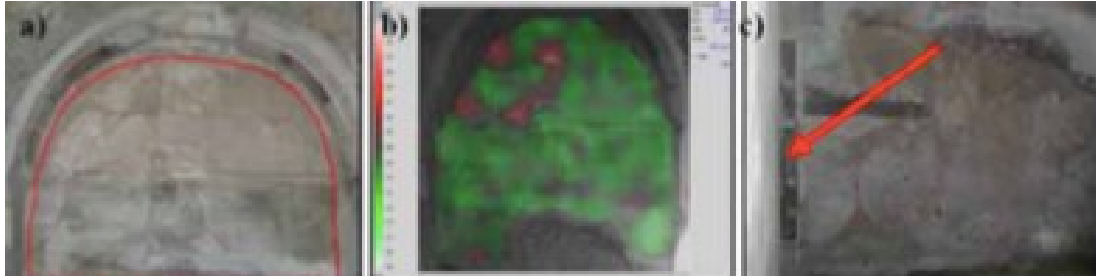
In the figure (5-6) there is a picture of the wall with the relative map RMS. It is characterized by wide areas in phase of detachment from the support, in particular on the top right with a value of speed of vibration of 180 $\mu\text{m/s}$.

(Figure 5-6) (a) wall (b) RMS map (c) constructive detail [9.]

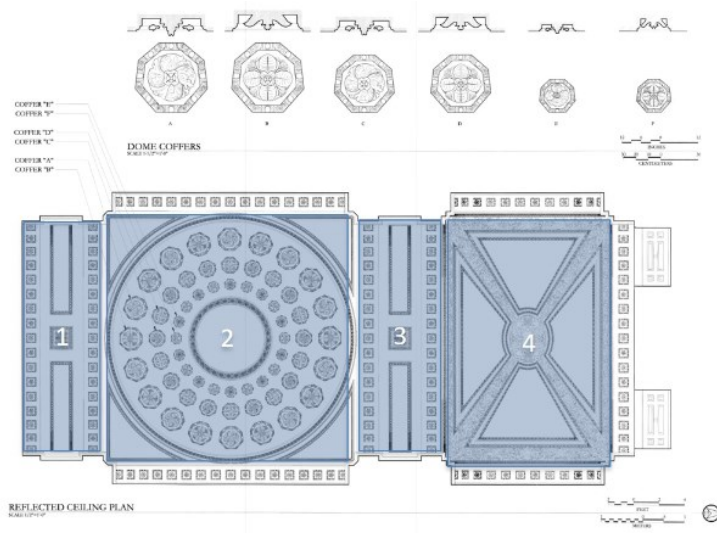
(Figure 6-1) [13.]

The ceiling is separated into four areas of two archways and two domes (*Figure 6-1*). These areas include the south arch (1), the south dome (2), the north arch (3) and the north dome (4). (*Figure 6-2*) [13.]

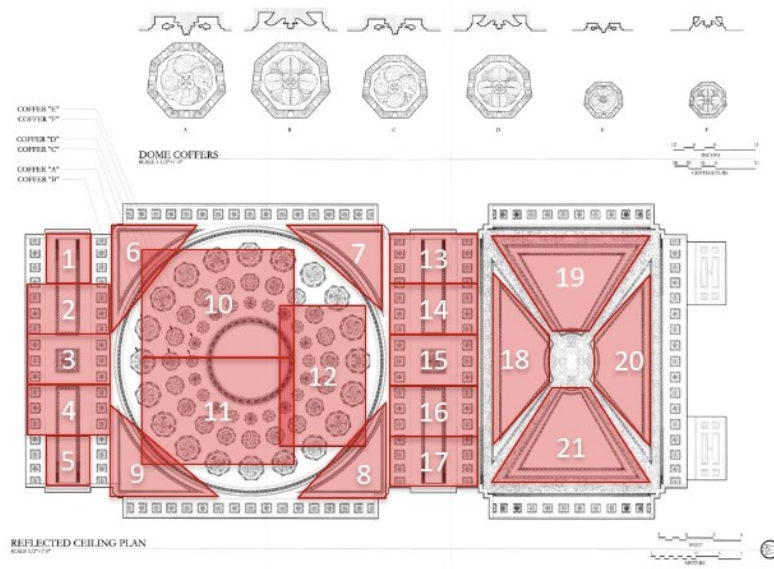
(Figure 6-2) [13.]

Two major anomalies were found in this area, one in the lower west portion (Section 1) and one in the middle of the east portion of the archway (Section 4). Sections 2, 3, 5 show little or no evidence of degradation. [13.]

Two major anomalies were found in this area. One is considerably smaller in the upper right area of the south west portrait (Section 6). The other is considerably largest in the entire central portrait at the peak of the dome (Section 10-11). Sections 7, 8, 9, 12 show little or no evidence of degradation.

Two major anomalies were found in this area, one in the center of lower west portion (Section 13) and one in the center of lower east Portion (Section 17). Sections 14, 15, 16 show little or no evidence of degradation. [13.]

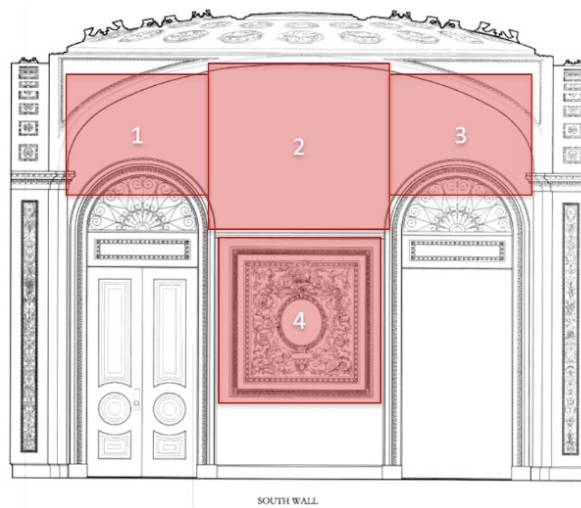
The south wall is separated into three sections of the lunette (Section 1-2-3) as well as the portrait of the Senator Clay in the center (Section 4). (Figure 6-14) [13.]

The wall shows a number of small anomalies in the center of lunette (Section 1-2) and two large anomalies around the border of the portrait (Section 4). Section 3 shows little or no evidence of degradation.

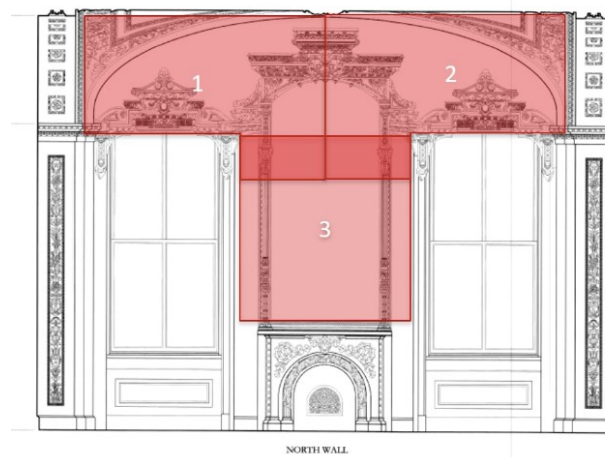
(Figure 6-18) [13.]

The north wall is separated into two sides of the lunette (Section 1-2) as well as the center portion of the wall between the windows (Section 3). (Figure 6-18)

Anomalies on the north wall include three large areas along the windows (Section 3) and few small areas in the top of the lunette (Section 1-2). [13.]

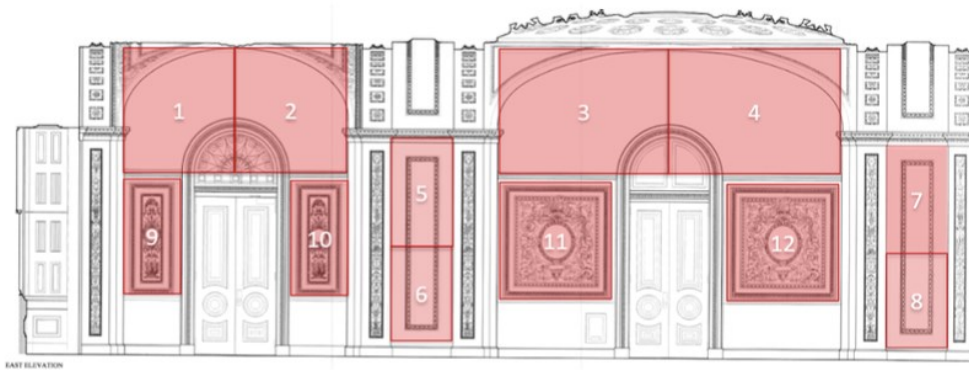
The south wall is separated into four sections. These areas include both lunettes (Section 1-2-3-4), the panels surrounding the north door (Section 5-6-7-8), the north and the south medals panels (Section 9-10) and the two portraits of Senators Taft and Calhoun (Section 11-12). (Figure 6-22) [13.]

The wall shows a number of small and large anomalies along the upper edges and bottom corners of the lunettes (Section 1-2-3-4). Both medals panels have large single anomalies (Section 5-6-8). The northern door panel shows a large central anomaly while the southern door panel shows four (Section 9-10). The outer plaster surrounding the portrait of Senator Taft shows a large anomaly running along the bottom edge (Section 11). Section 7, 12 shows little or no evidence of degradation.

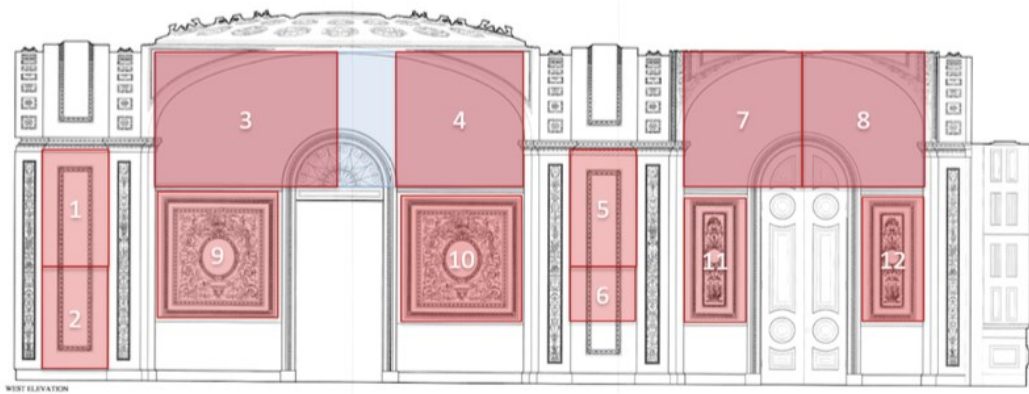
(Figure 6-33) [13.]

The west wall is separated into four sections. These areas include the south medals panel (Section 1-2), the south lunette (Section 3-4), the north medals panel (Section 5-6), the north lunette (Section 7-8) the portraits of senator Lafolette and Webster surrounding the south door (Section 9-10) and the panels surrounding the north door (Section 11-12). *(Figure 6-33) [13.]*

The wall shows multiple large anomalies in the upper medals panels (Section 1-5) and smaller anomalies in the door panels (Section 11-12). The northern lunette shows three small anomalies around the edge (Section 7-8). The southern lunette contains two large anomalies (Section 3). Section 2, 4, 6, 9, 10 shows little or no evidence of degradation. [13.]
